# Fort Sumter

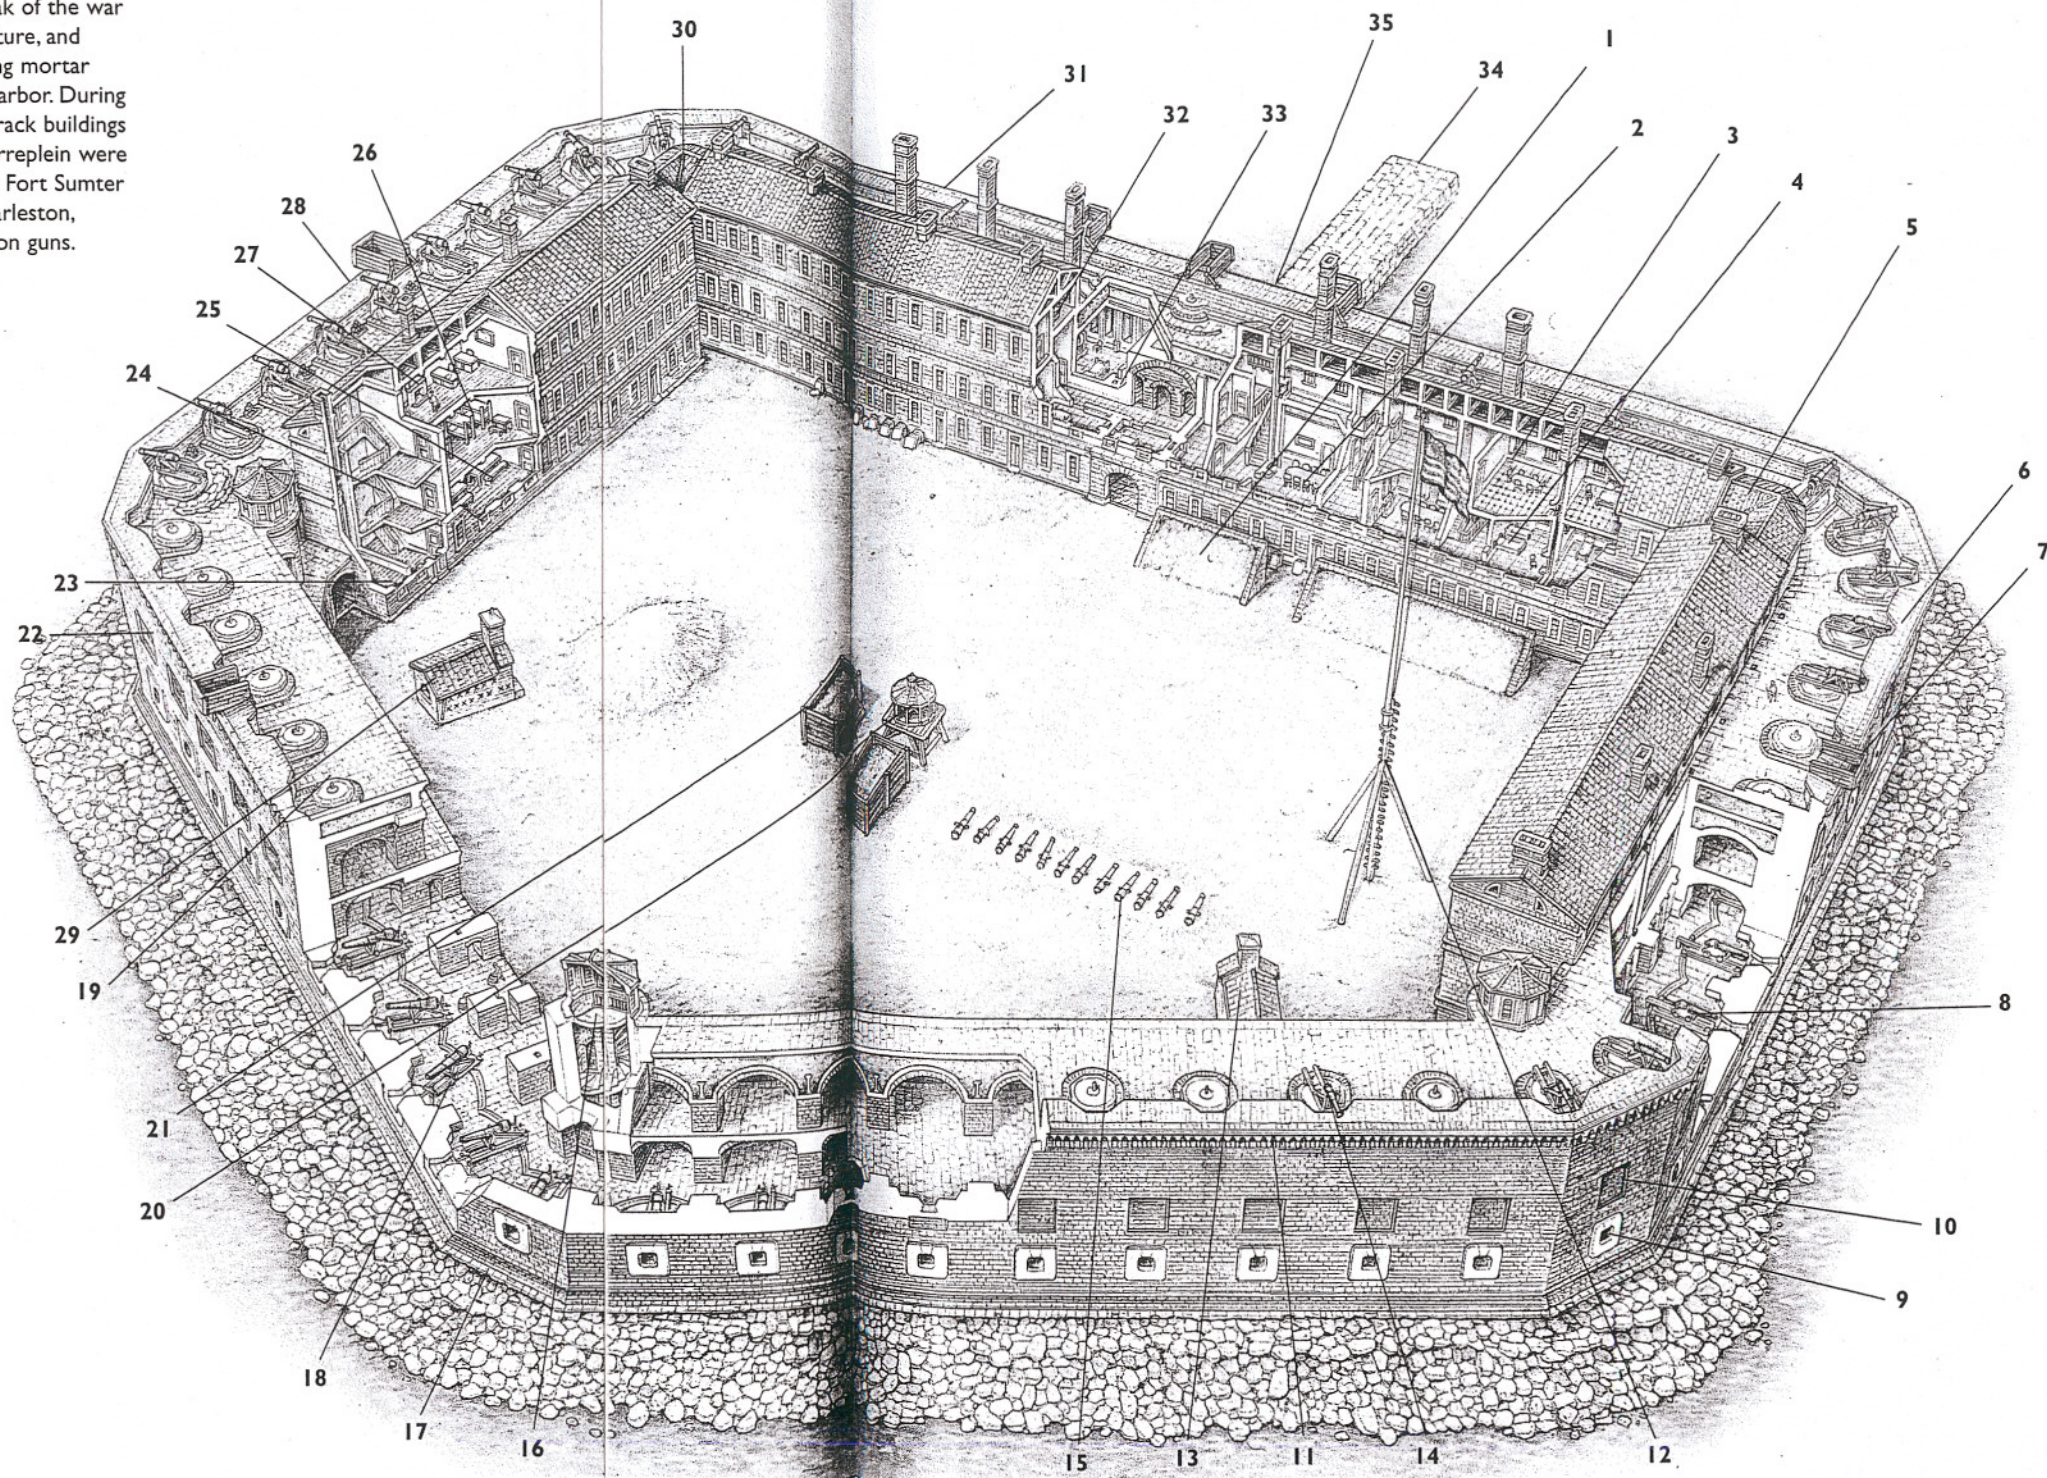
Fort Sumter, built to protect the port of Charleston, South Carolina is best known for the role it played at the start of the Civil War, where its small Union garrison was bombarded for two days. This view of the fort immediately before the outbreak of the war shows the imposing nature of the structure, and demonstrates its vulnerability to plunging mortar fire from batteries ranged around the harbor. During the Confederate bombardment the barrack buildings were destroyed, and the guns on the terreplein were put out of action. In Confederate hands Fort Sumter continued to help in the defense of Charleston, despite being reduced to rubble by Union guns.

- 1 Bombproof traverses
- 2 Officers' dining rooms
- 3 Fort commander's private quarters
- 4 Officers' quarters
- 5 North west stairwell
- 6 Northern scarp
- 7 Sharpshooter's platform
- 8 Smoothbore columbiad on wooden garrison carriage
- 9 Lower casemate tier
- 10 Upper casemate tier
- 11 North east scarp
- 12 Flagpole
- 13 Hot-shot furnace
- 14 Columbiad smoothbore on *en barbette* carriage
- 15 Unmounted ordnance
- 16 Central stairwell tower
- 17 The salient
- 18 Rodman smoothbore on iron casemate carriage
- 19 Terreplein
- 20 Belfry
- 21 Grit boxes
- 22 South east scarp
- 23 Cookhouse store
- 24 Internal stairway
- 25 Enlisted mens' dining hall
- 26 Enlisted mens' barrack rooms
- 27 Offices
- 28 Southern scarp
- 29 Magazine
- 30 South-western stairwell
- 31 Gorge wall
- 32 Offices
- 33 Officer's quarters
- 34 Stone-built jetty
- 35 Sally port
